Types of Wave Solder Defects

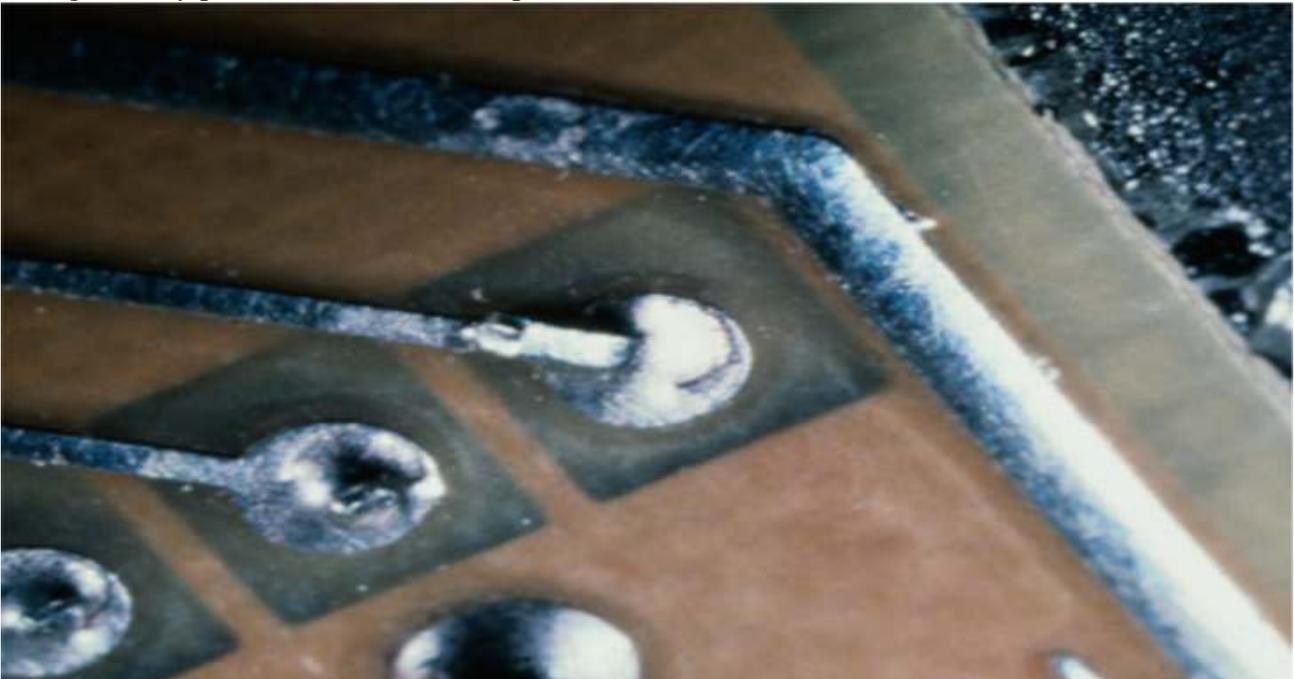
Recognized by pull back of solder to expose the surface to be soldered

Non Wetting - Possible Causes:

Grease, oil or dirt on the pre-soldered surface
Bleeding or misregistered soldered mask
Low temperature solder
Contaminated solder
Surfaces too heavily oxidized for flux being used
Contaminated flux
Poor application of flux

Investigate each possible cause and correct suspected discrepancies one at a time until solderability is restored

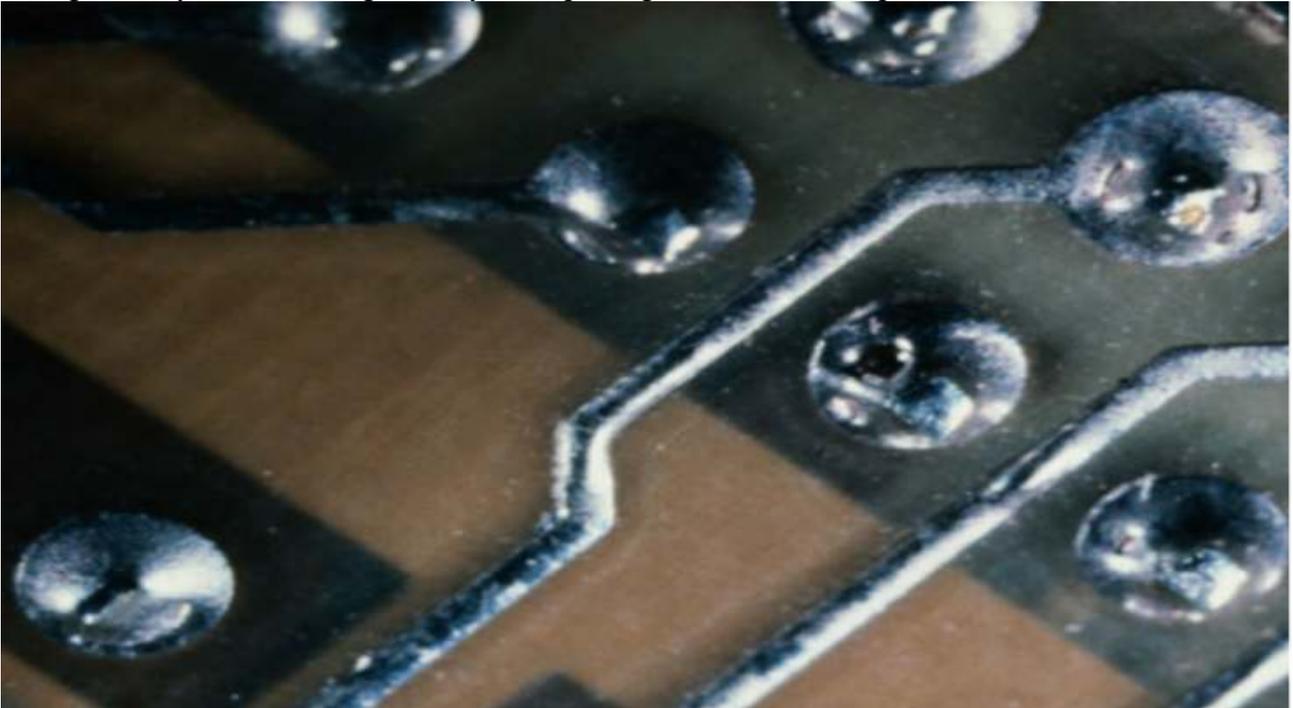
Recognized by metal wetting initially, then pulling back to form droplets of solder on the surface.

Dewetting - possible Causes:

Contamination of surface by abrasives

Poor plating

Poor hot air solder leveling during PCB manufacture

Restore solderability of the surface

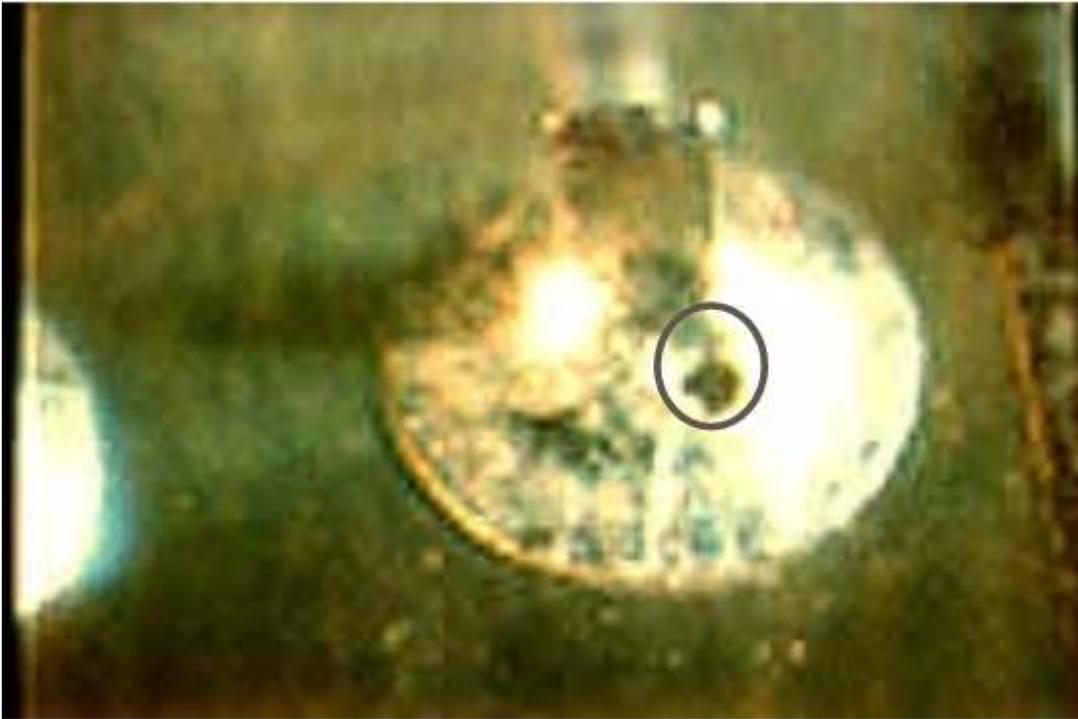
Recognized by small holes or eruptions in the solder fillet.

Pin Holes - possible Causes:

- Moisture or plating solution in the PCB laminate
- Inadequate preheat to evaporate flux solvent
- Flux has absorbed water
- Physical blockage due to foreign body in hole
- Top of Plated Through Hole prematurely solidifying

- Increase preheat to see if it eliminates problem
- Put in new flux to see if it eliminates problem
- Increase topside preheat and/or solder temperature to correct premature topside Plated Through Hole freezing
- If all of these fail to correct the problem, have the PCBs baked and cross sectioned.

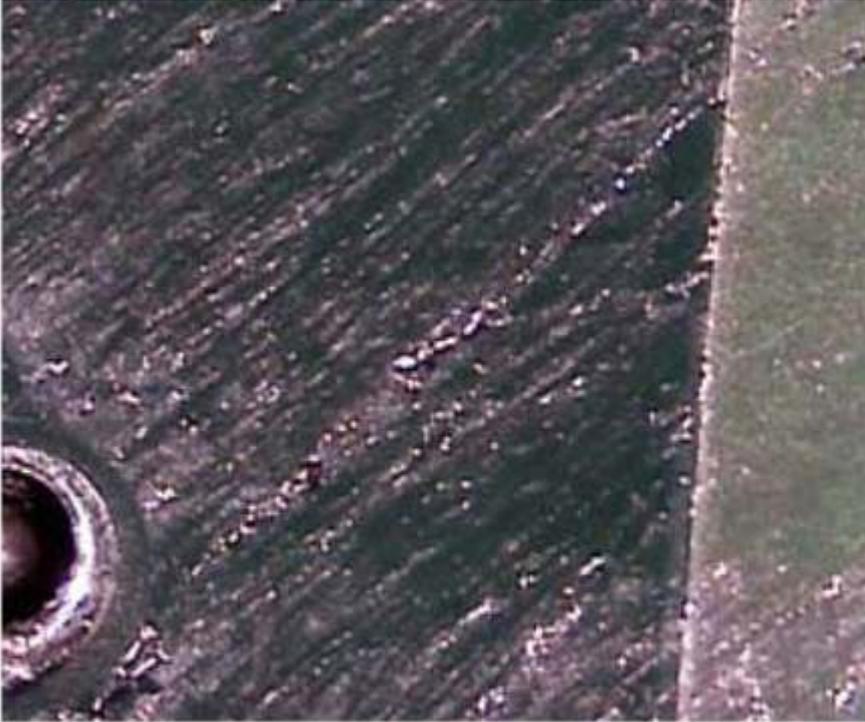
Webbing

Recognized by a spider web like extension of solder across the non conductive portion of the PCB.

Possible Causes:

- Improper curing of the laminate or solder mask
- Inadequate flux (when accompanied by bridging or icycling)
- Dross in the solder wave

- Baking the PCB will sometimes correct the improperly cured mask or laminate condition
- Substituting a more viscous flux or increasing the quantity of flux put on the PCB
- Correcting the drossing problem in the wave

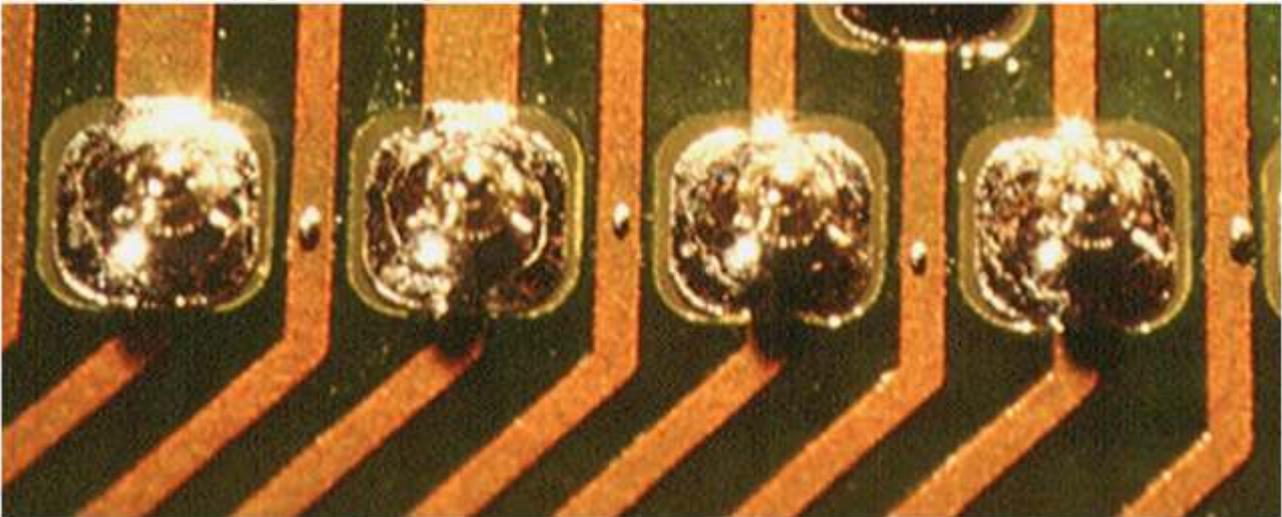
Recognized by tiny spherical shapes of solder dispersed over the surface of the PCB

Possible Causes:

Insufficient preheat

Plated Through Hole conditions that create pin holes, resulting in Solder Balls

High humidity in the manufacturing area

Moisture in the flux

Investigate each possible cause, correcting suspect causes one at a time until the problem is corrected.

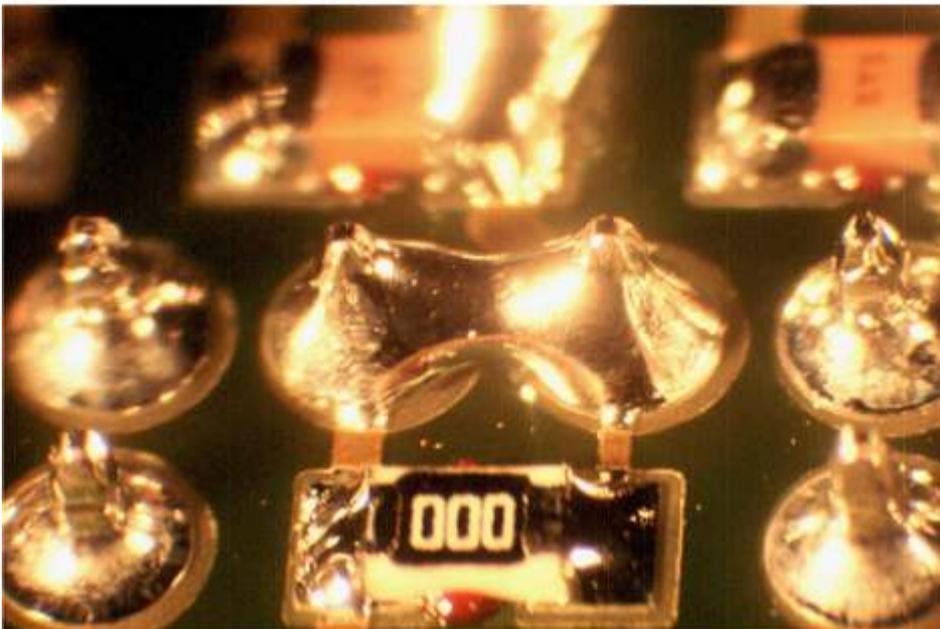
Bridging

Recognized by solder extending from one lead to an adjacent lead, causing a short circuit

Possible Causes:

Component leads that are bent or too closely spaced
Excess solder
Inadequate flux remains to promote drainage
Board immersed too deep in the wave
Leads picking up dross in the wave
Contaminated solder
Poor component solderability

Investigate each possible cause and correct suspect conditions one at a time until the condition is eliminated

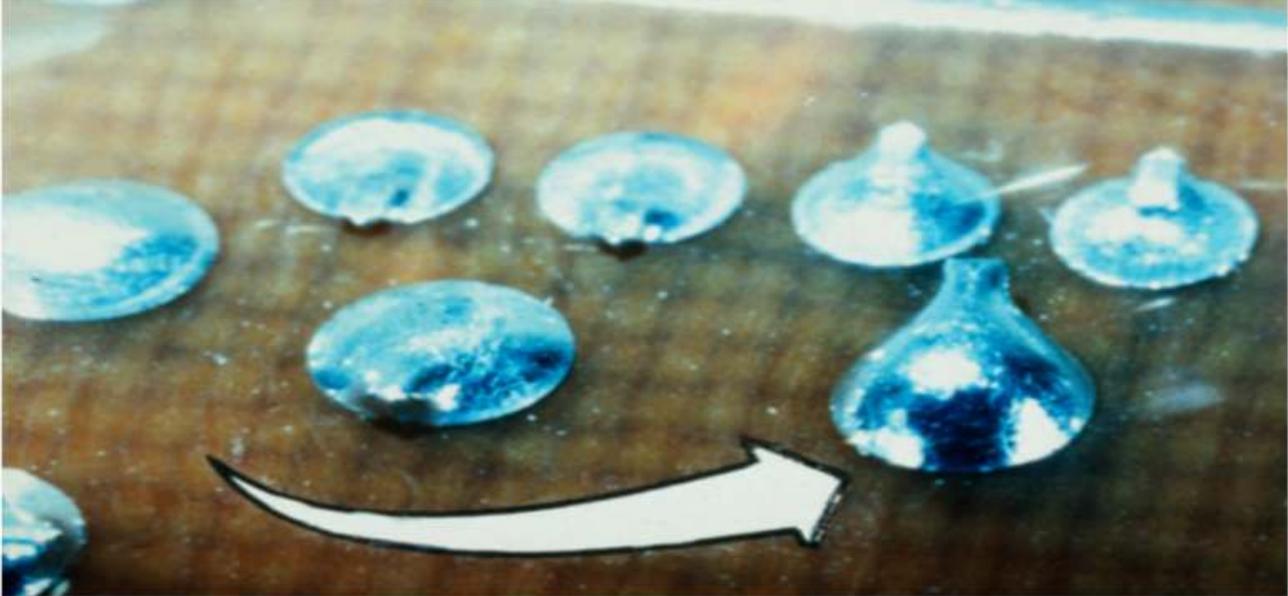
Excess Solder

Bulbous appearance of fillet.

Unable to see contours of lead and land.

Possible Causes :

Any condition that contributes to poor drainage of the solder

Low temperature of solder or preheat

Contamination of solder

Insufficient flux to promote drainage

Incorrect wave exit angle or speed

Investigate suspected causes and correct them one at a time until the problem is corrected
